# Manhole Inspection Summary

Manhole # S13MM\_050MH

Insp Date: **8/31/07 12:04 PM**

**Location** Address: **REAR 2212 POPLAR GROVE ST** Cross Street: **POPLAR TERR.**

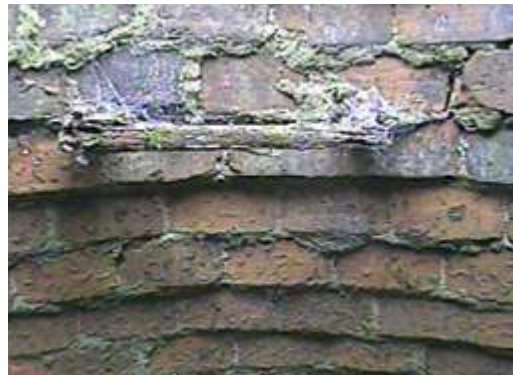
Defect 1

**Steps** Count: **3** Missing: **0** ☒ **Corroded**

CORRODED RUNG

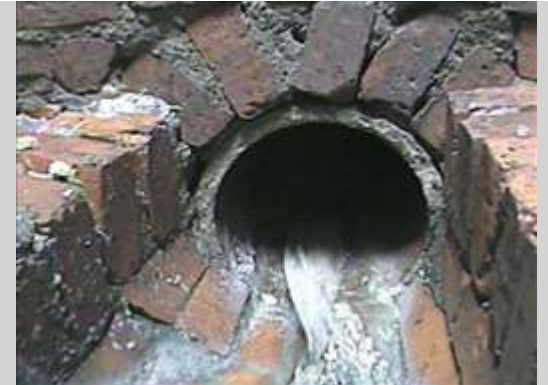
12 O'Clock Outflow

8 in. Circular Gravity Sewer  
Pipe Out @ 12 O'Clock

Pipe Height: (in.) Direct  
Pipe Material: **Clay** ☐ Pipe Lined  
Invert Depth: **6.80** (ft.) Flow Characteristics: **Fast**  
Deposits: ☐ None ☐ Mud ☐ Sludge ☒ **Debris** ☐ Grease  
Silt Depth: **0.5** (in.) Deposits Extent: **Light**  
Infiltration: **None** Pipe Seal Cond: **Cracked**

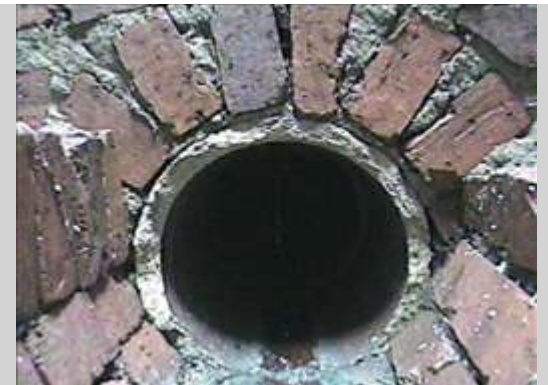
6 O'Clock Inflow

8 in. Circular Gravity Sewer  
Pipe In @ 6 O'Clock

Pipe Height: (in.) Direct  
Pipe Material: **Clay** ☐ Pipe Lined  
Invert Depth: **6.71** (ft.) Flow Characteristics: **Fast**  
Deposits: ☒ **None** ☐ Mud ☐ Sludge ☐ **Debris** ☐ Grease  
Silt Depth: (in.) Deposits Extent:  
Infiltration: **None** Pipe Seal Cond: **Cracked**

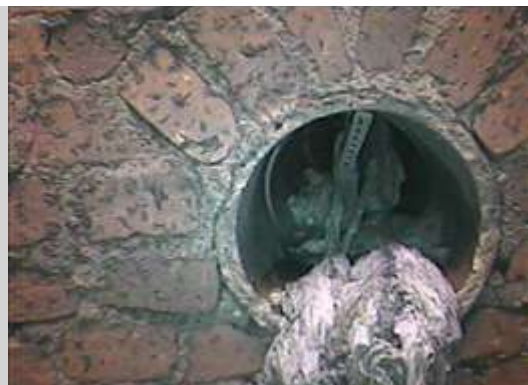
9 O'Clock Inflow

Pipe In @ 9 O'Clock

Deposits: ☐ None ☐ Mud ☐ Sludge ☒ **Debris** ☐ Grease

Silt Depth: **3** (in.) Deposits Extent: **Medium**

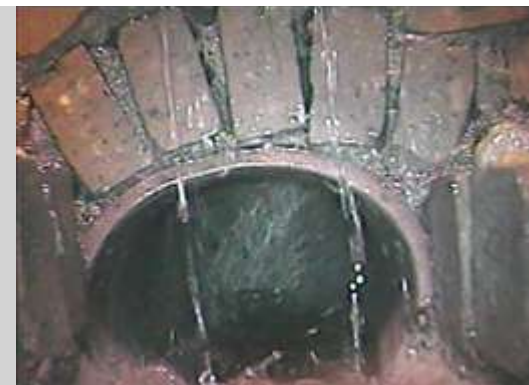
Drop In @ 9 O'Clock

Drop: **Outside** **Direct**

Drop Condition: **Partly Clogged**
